6.0 Grand Junction, Colorado, Disposal Site

Figure 6-1. 2003 Annual Compliance Drawing for the Grand Junction, Colorado, Disposal Site

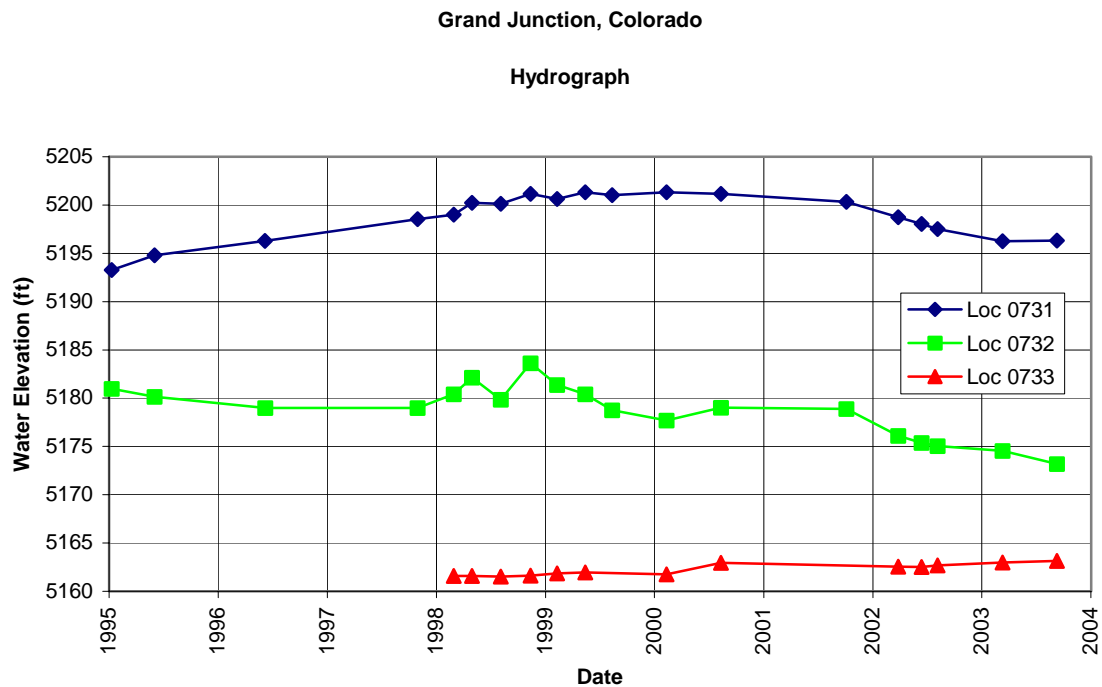
Figure 6-2. Water Level Measurements at the Grand Junction, Colorado, Disposal Site

In lieu of monitoring ground water in the uppermost aquifer, ground water in two monitor wells in or very near buried alluvial paleochannels adjacent to the disposal cell (MW-0731 and MW-0732) and one monitor well in the disposal cell (MW-0733) is monitored to assess performance of the disposal cell and to ensure that any water in the paleochannels is not impacted by seepage (transient drainage) from the disposal cell (Figure 6-1). The paleochannel wells are along the west (downgradient) edge of the disposal cell and are screened at the interface between the alluvium and shallow Mancos Shale. The third well is in the southwest corner of the open portion of the disposal cell and is used primarily for measurement of water levels in the deepest part of the disposal cell to demonstrate that intracell water will not rise high enough to move laterally into the paleochannels. The water level in the disposal cell well is approximately 35 and 10 feet lower (deeper) than water levels in the paleochannels at MW-0731 and MW-0732, respectively (Figure 6-2). This indicates that ground water cannot seep from the disposal cell to the paleochannels.

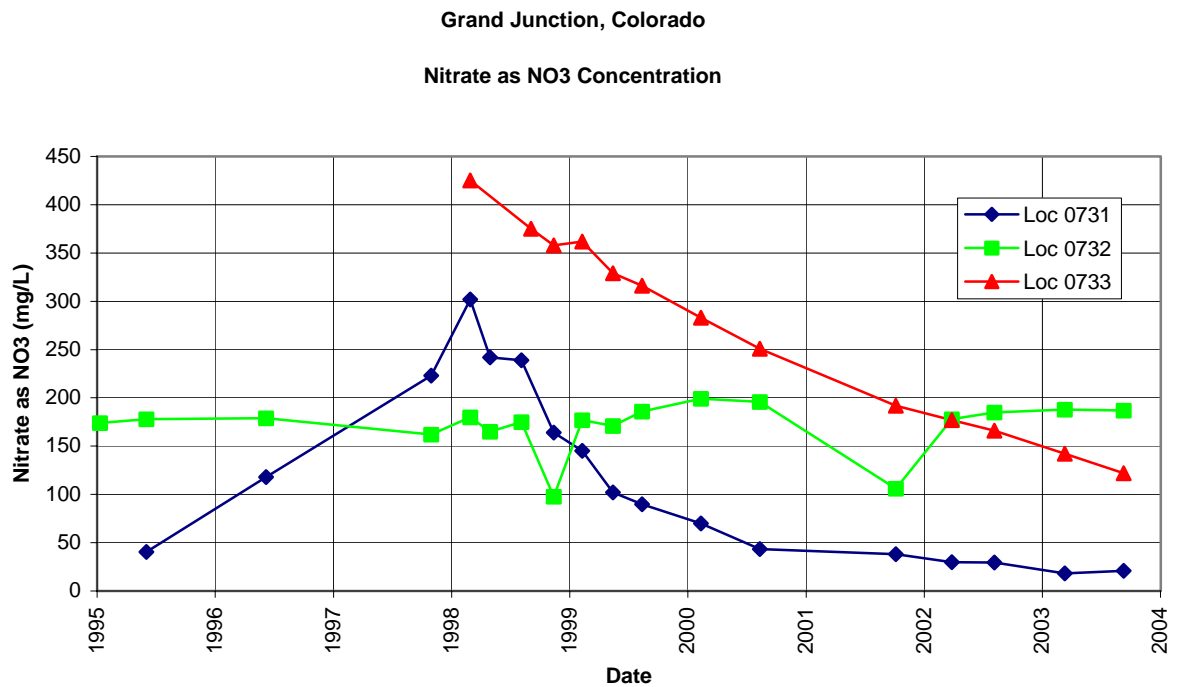
Figure 6-3. Time-Concentration Plots of Nitrate (as NO₃) in Ground Water at the Grand Junction, Colorado, Disposal Site

Results from sampling in 2003 were consistent with results from the past several years. Molybdenum and vanadium concentrations in ground water continued to be near or below the required laboratory detection limits and significantly below the MCL or risk-based standard at all wells. Nitrate concentrations exceeded the MCL of 44 mg/L in MW-0732 and MW-0733, but were below the MCL in MW-0731 (Figure 6-3). Selenium levels continued to exceed the MCL of 0.01 mg/L at both downgradient wells and remained below the standard at MW-0733 (Figure 6-4). Sulfate concentrations continued to be relatively high in all wells, at approximately 6,700 mg/L in the disposal cell, and just below 4,000 mg/L in the paleochannel wells. High sulfate concentrations are typical of the regional soils, which contain gypsum. Concentrations of TDS continued above 10,000 mg/L in the disposal cell well. Concentrations of TDS in ground water in the paleochannel wells were around 7,000 mg/L. Uranium concentrations were just below the MCL of 0.044 mg/L in MW-0731, and were substantially below the MCL in MW-0732 and MW-0733 (Figure 6-5). PCBs were not detected in the samples from any of the wells.

Monitoring results indicate ground water in the paleochannels has not been affected by transient drainage from the disposal cell. This is expected because water levels in the paleochannels are higher than in the disposal cell. Elevated levels of nitrate, sulfate, and uranium in ground water in the paleochannels are most likely due to leaching of natural soils and weathered shale around the paleochannels. Increased runoff from the cell surface may have increased moisture in the soils, paleochannels, and weathered shale around the disposal cell, which would increase the mobility of naturally occurring concentrations of nitrate, sulfate, and uranium in these materials.

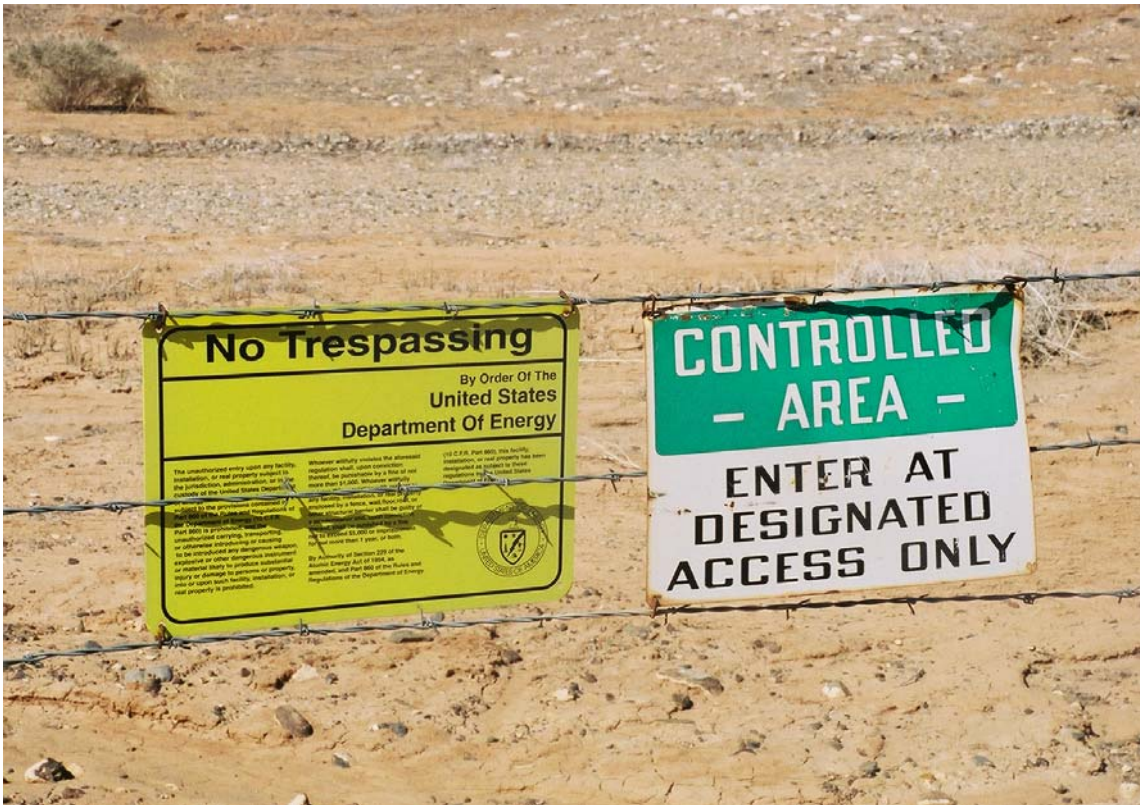
Additional warning signs are posted on the wire perimeter fence and are associated with the operation of the open cell. "Controlled Area" signs and "No Trespassing" signs are secured to the fence in pairs (PL-1). There are 75 warning sign locations, each about 200 feet apart along the site boundary.

GRJ 03/2003. PL-1. Warning signs on the perimeter fence.

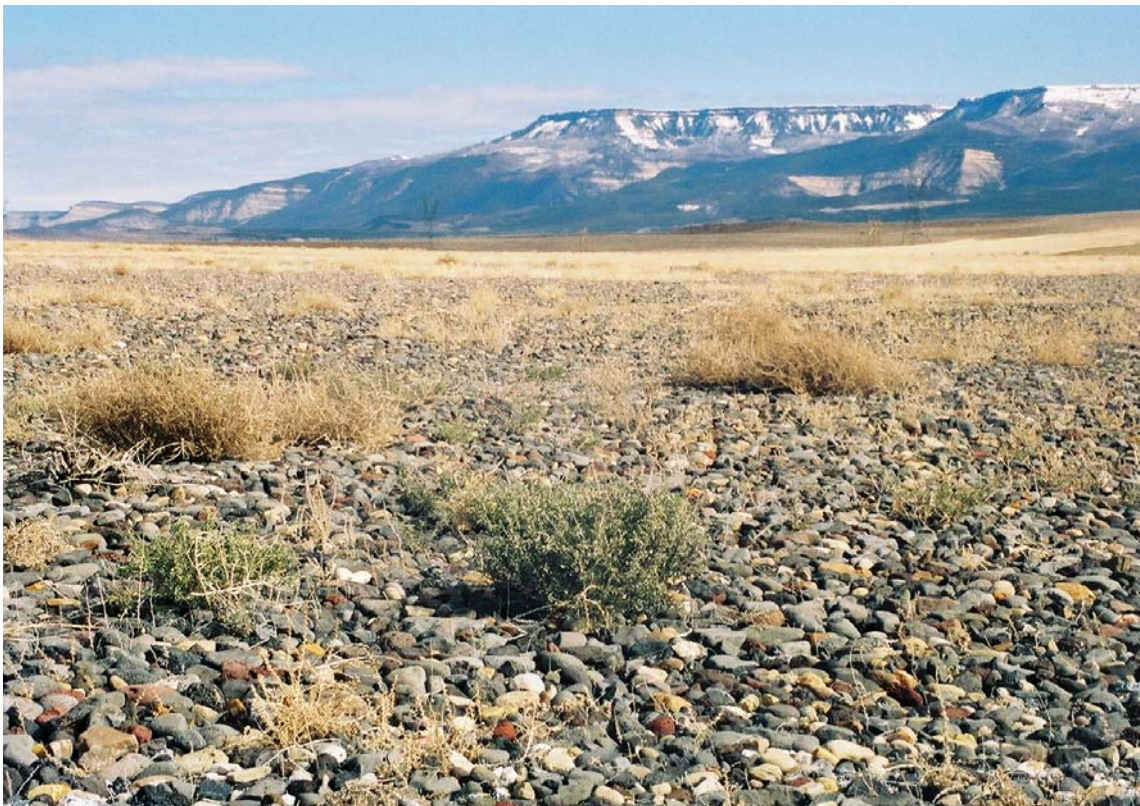
6B Minimal plant encroachment was observed on the side slopes. However, plant encroachment is occurring on the cell top, mostly on the southeastern part of the cell (PL-2). Deep-rooted plants, which were cut back and treated with herbicide in 2001, may change the performance characteristics of the radon/infiltration barrier. An investigation is underway by DOE to evaluate whether or not the deep-rooted vegetation needs to be controlled. Until the evaluation is completed, these plants will be controlled.

GRJ 03/2003. PL-2. Scattered vegetation on cell top near the southeast corner of disposal cell.
